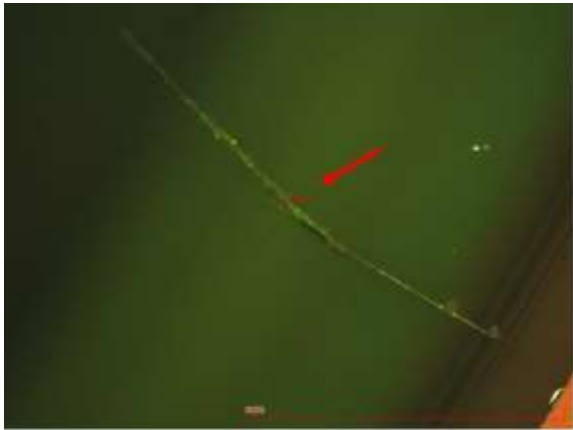
2.5 mm

Scratch on coating, 0.12 mm width on the widest marked area.

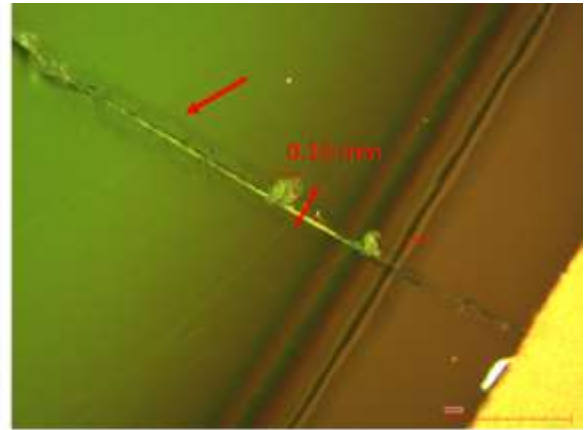
0.5 mm

Scratch on coating with inner cracks, 0.15 mm width on the widest marked areas.

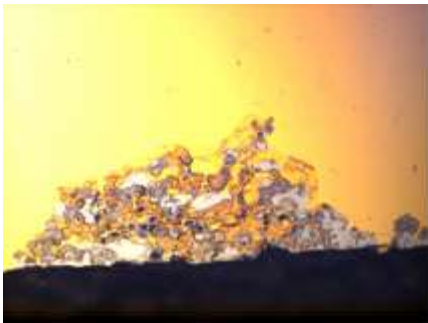
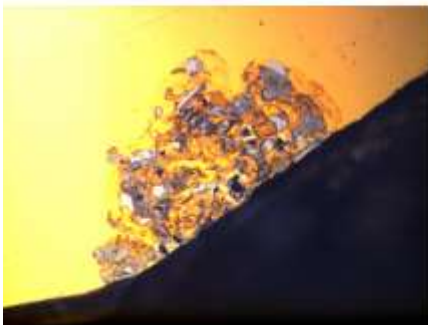
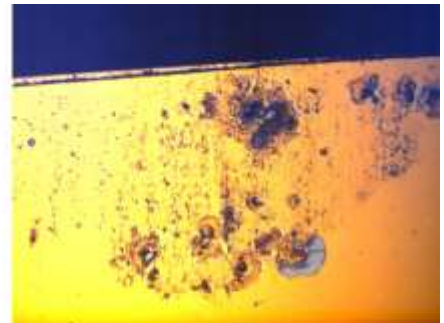
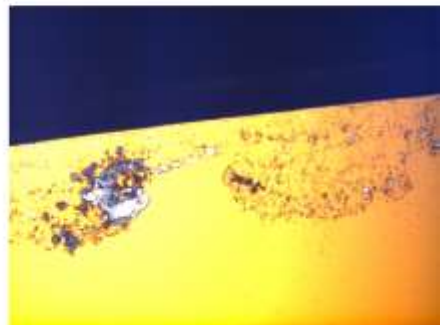
Disintegration of gold reflection coating at the edges of the mirror on left (two mirrors) and the same phenomenon on witness sample (one sample) of the same coating batch

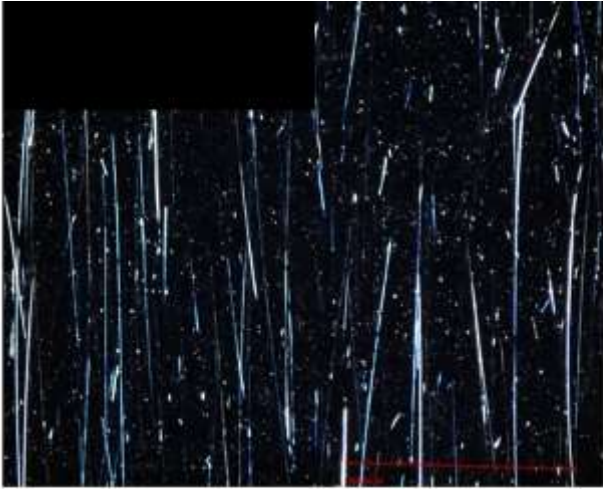
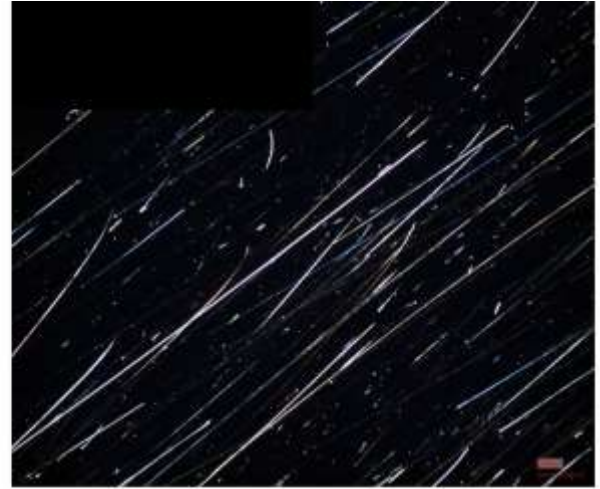
Scratches on the coating of copper coating mirror after moderate abrasion test (the same coating batch for the two mirrors)

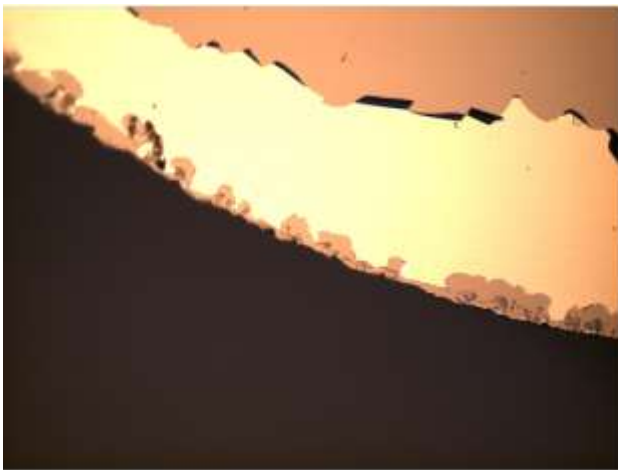
Peeling of reflection coating on the edge of the mirror.

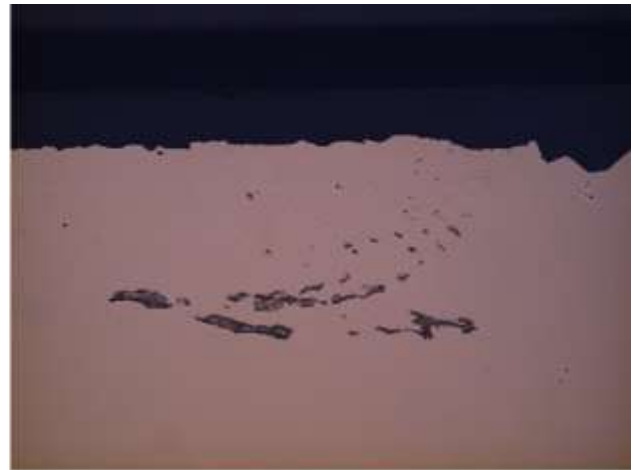
Peeling of coating on the edge of the element.

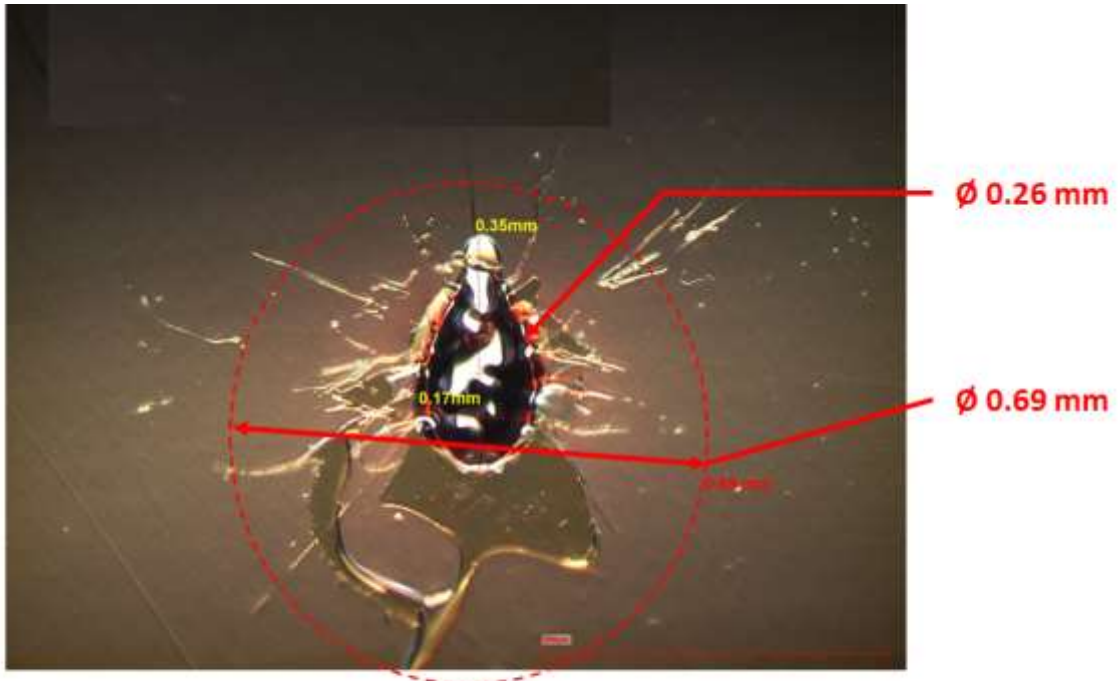
Deep dig with uplift of the IR coating, total of \varnothing 0.69 mm (the dig itself of \varnothing 0.26 mm).

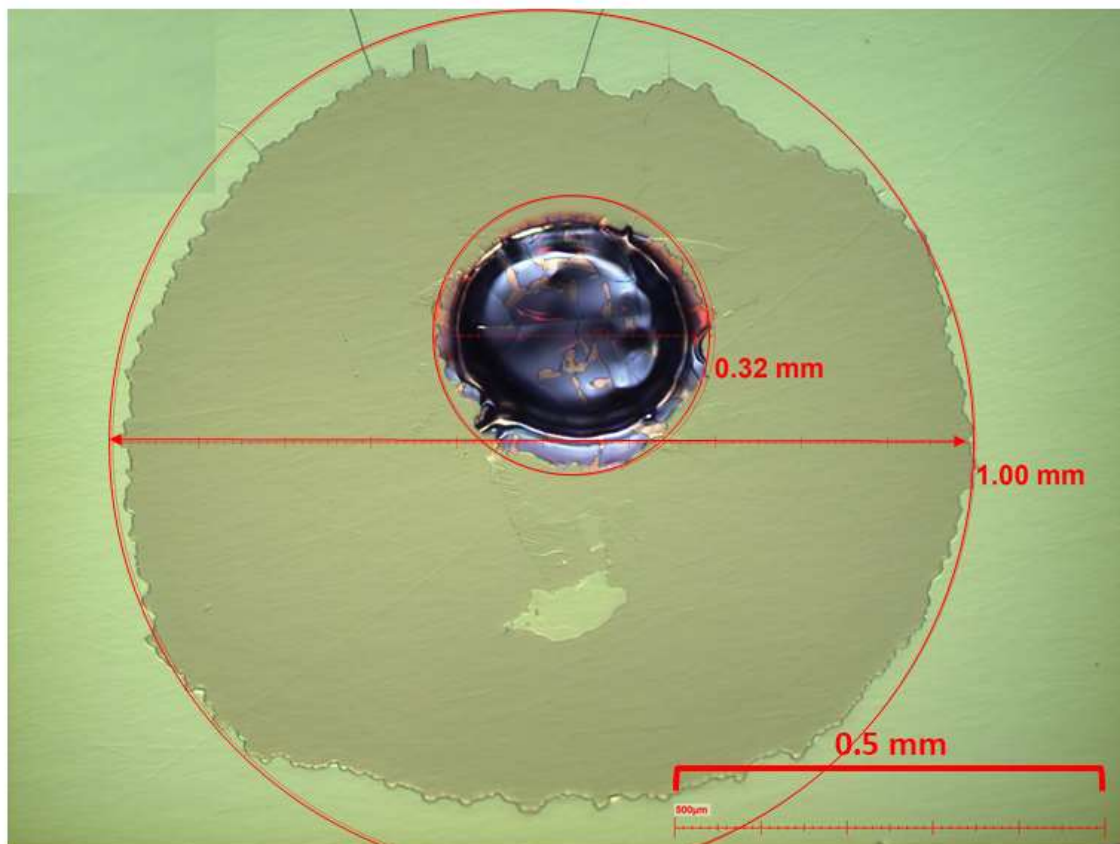
Dig of \varnothing 0.32 mm with coating peel on \varnothing 1.00 mm.

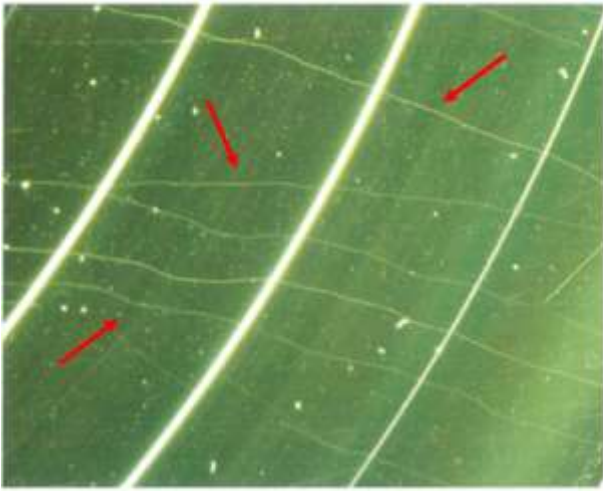
Cracks on IR coating of concave aspheric-diffractive surface

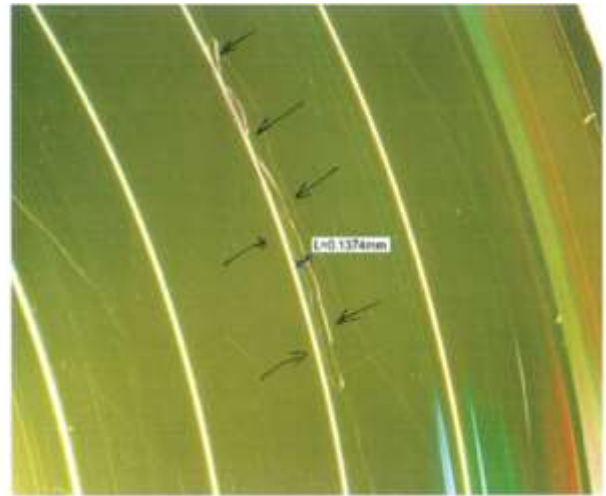
Peeling on IR coating of concave aspheric-diffractive surface, width of 0.1374 mm max.

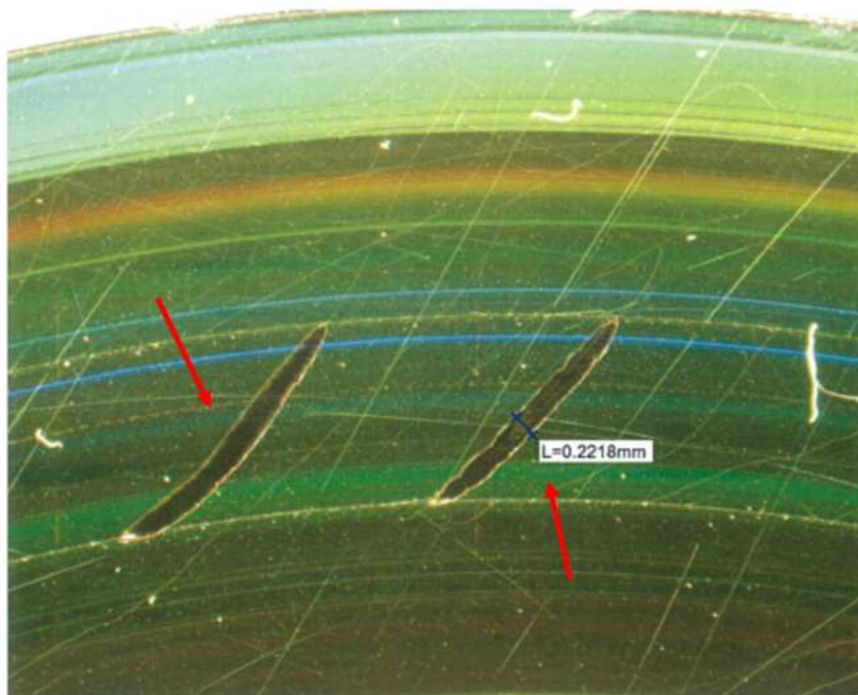
Peeling of the IR coating on concave aspheric-diffractive surface between two diffractive zones, width of 0.2218 mm on adhesion test

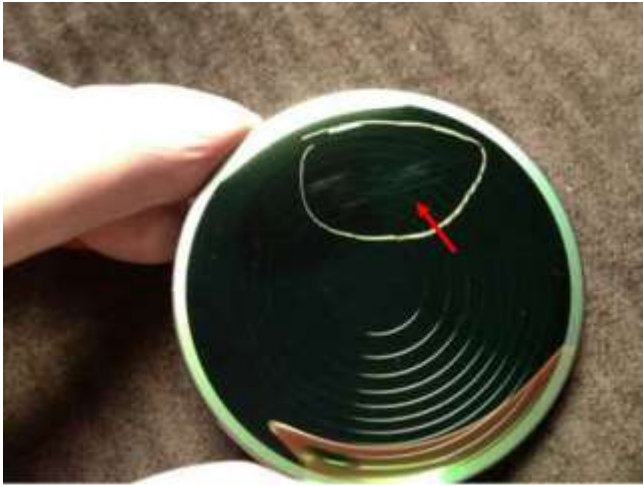
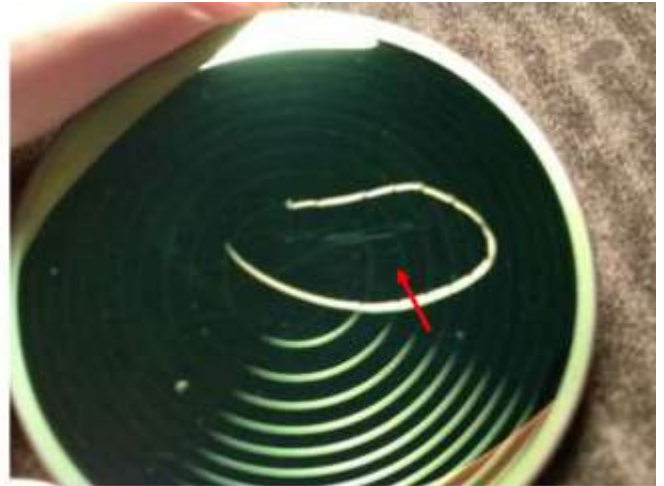
Scratches made by moderate abrasion followed the humidity test on real concave diffractive surface elements

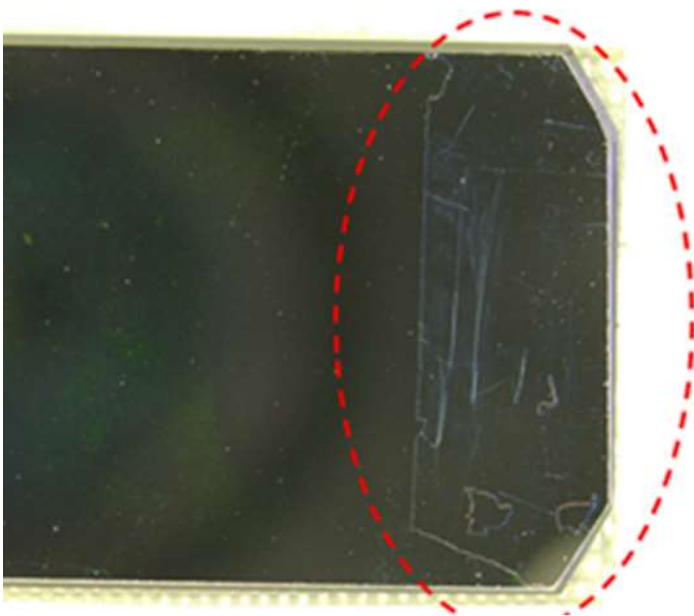
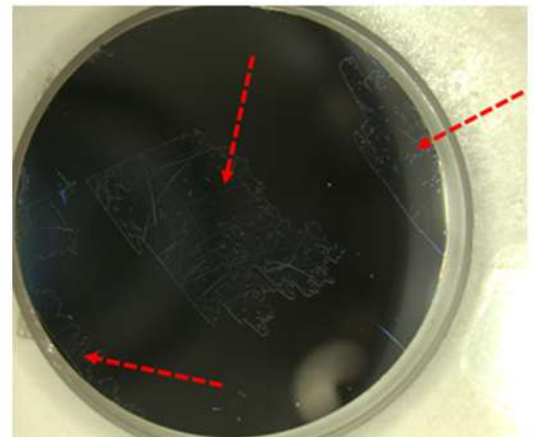
Peeling of the protective coating of Silver on the witness sample (right) and on real mirror (left) at adhesion test followed temperature test of the same coating batch

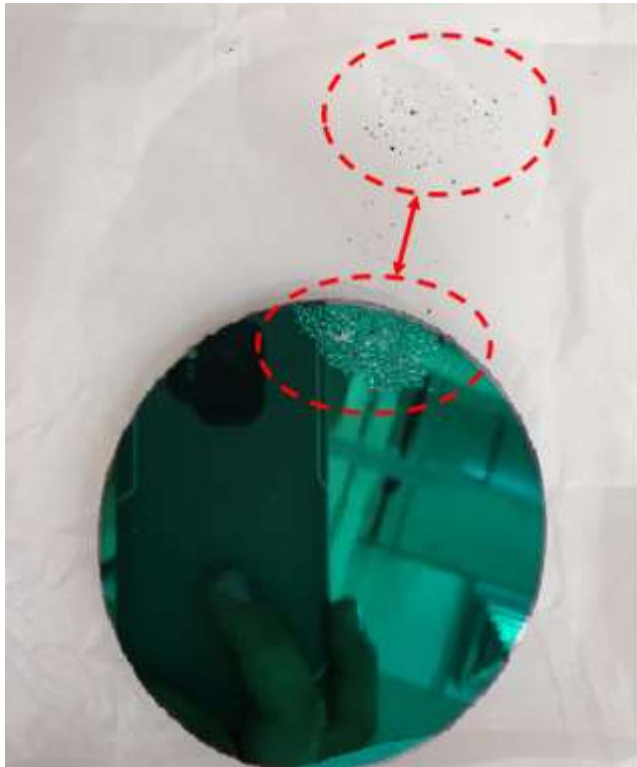
Disintegration of the coating of IR window, observed after opening the packaging

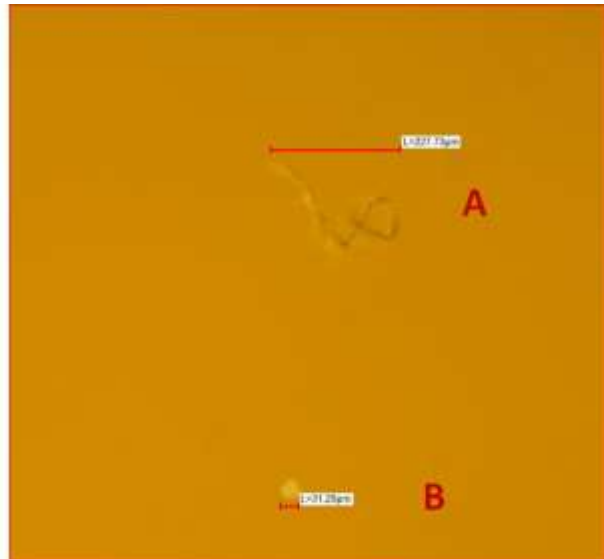
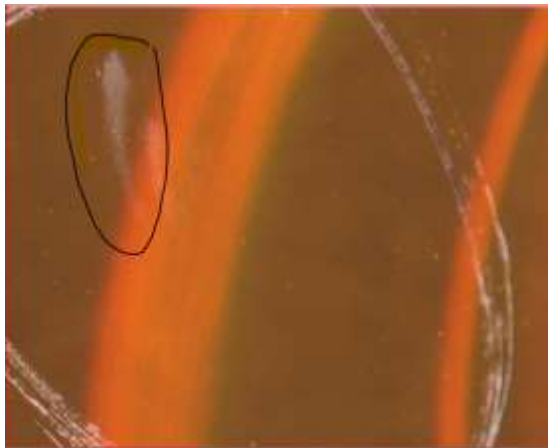
Some kind of Rubbing.

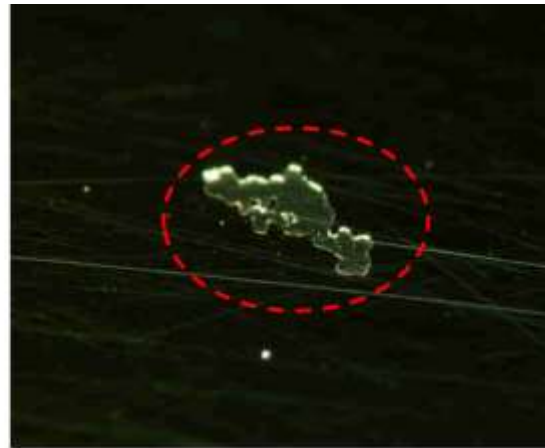
Peeling of the coating.

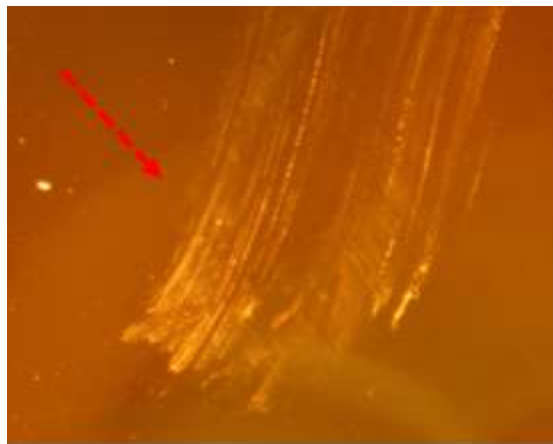
Rubbing due to bad handling
(on IR Coating).

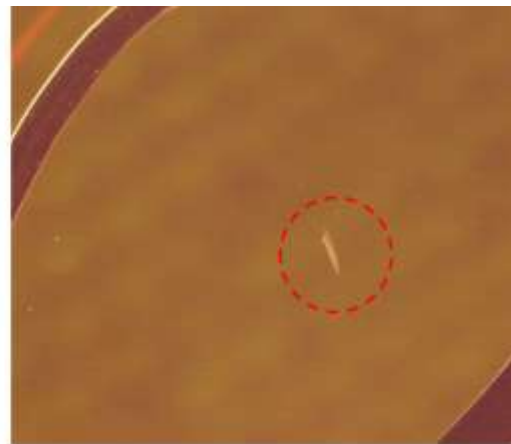
Some kind of defect
(on IR Coating).

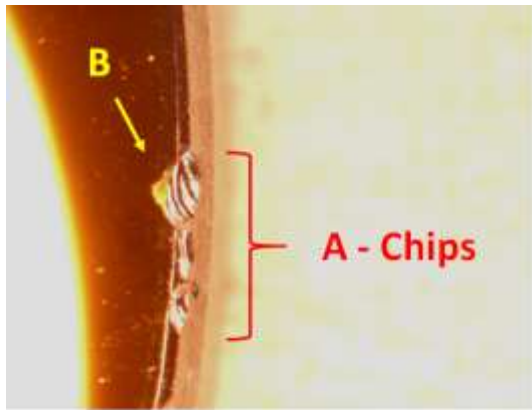
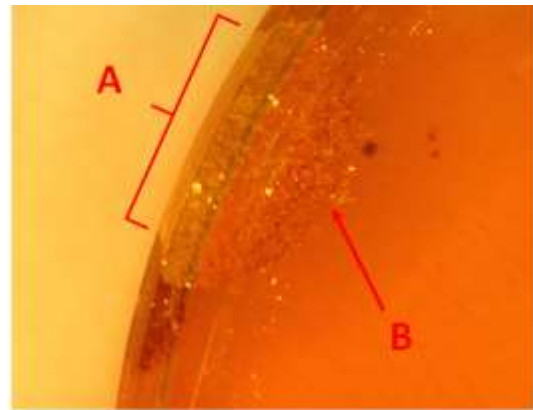
Mechanical damages due to production or handling process (A) at the edge of the element that penetrate the coated surface (B).

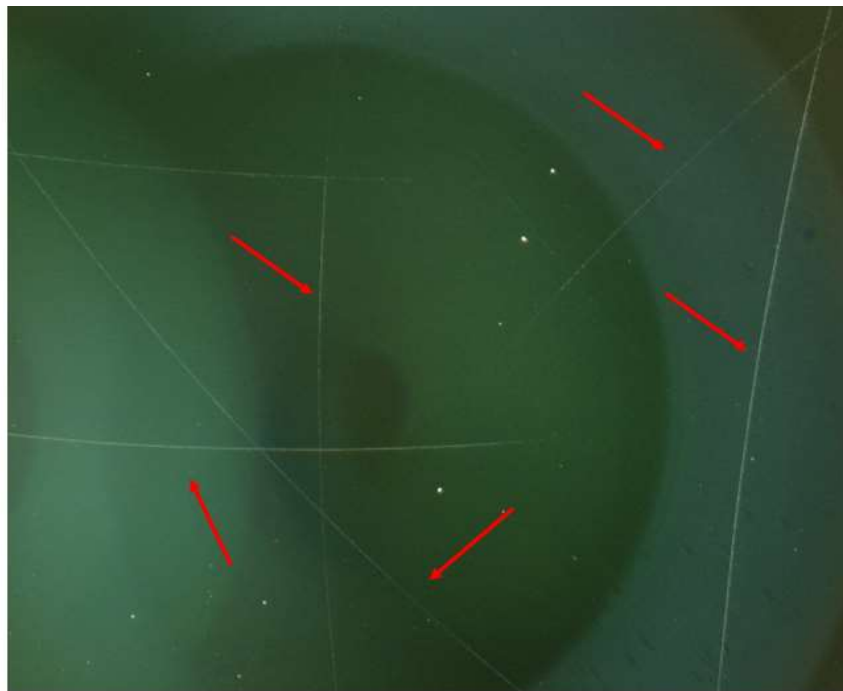
Sleeks (very thin polishing hairline scratches, seen also after coating process). Usually they do not influence on the functionality.

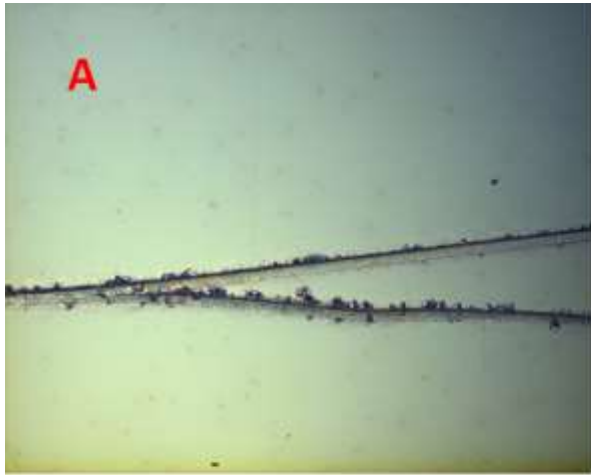
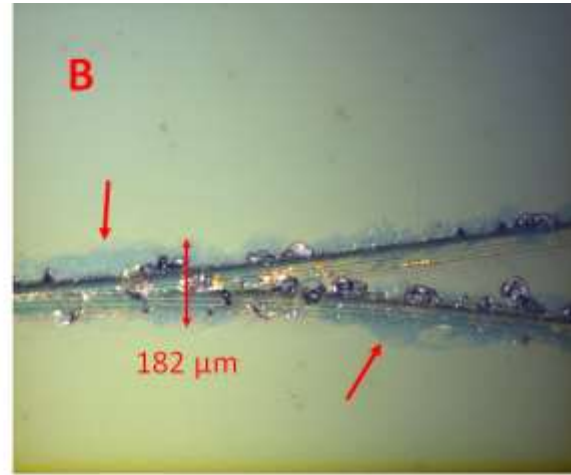
Scratches on coated surface. The same defect but the right picture (B) us with higher magnification than A and around the scratch (and part of it) we can see inner cracks.

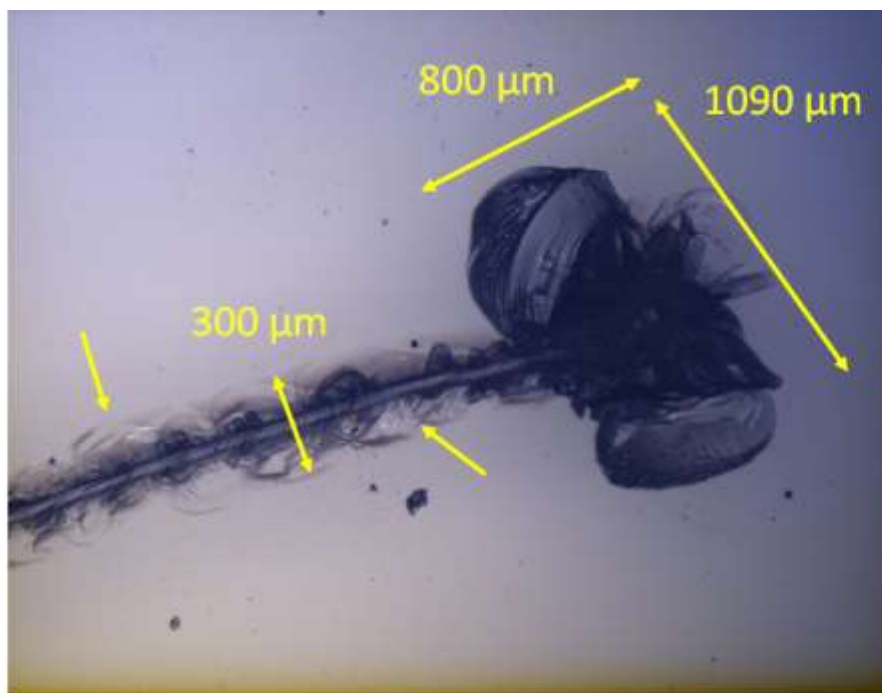
Dig with scratch with inner cracks on uncoated glass surface

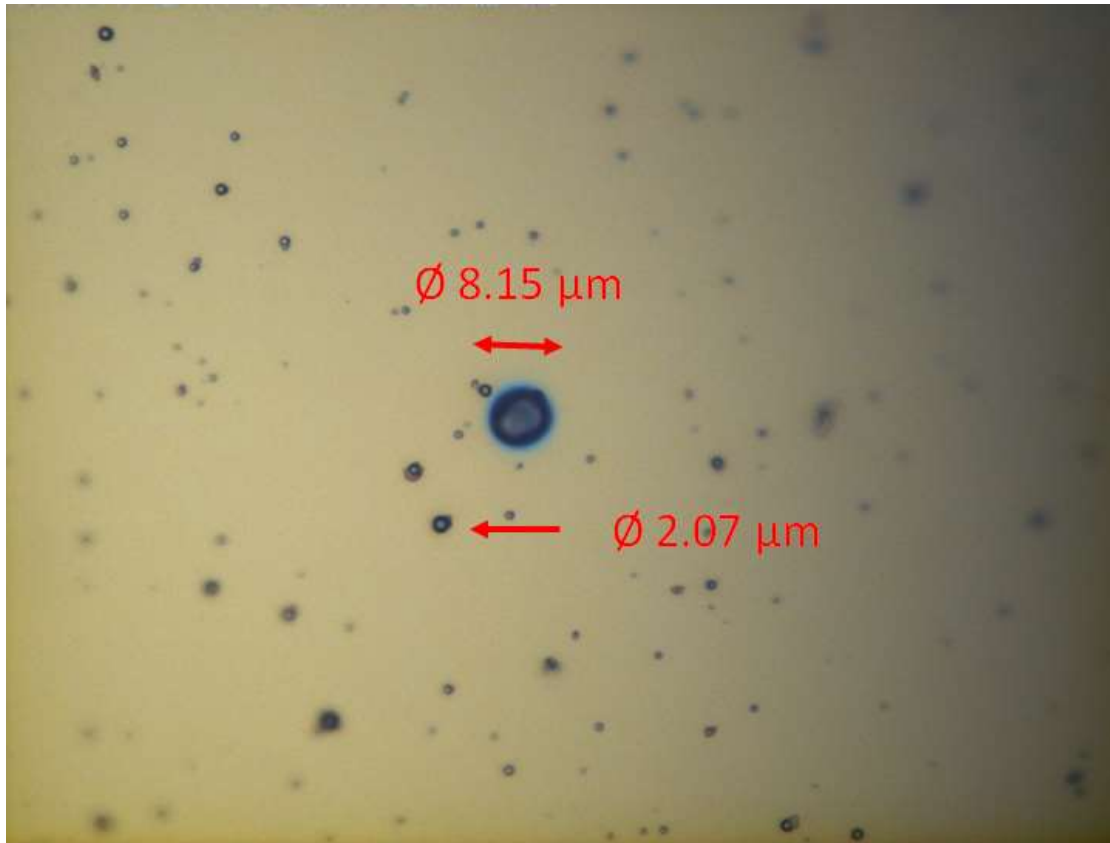
Pinholes in IR coating

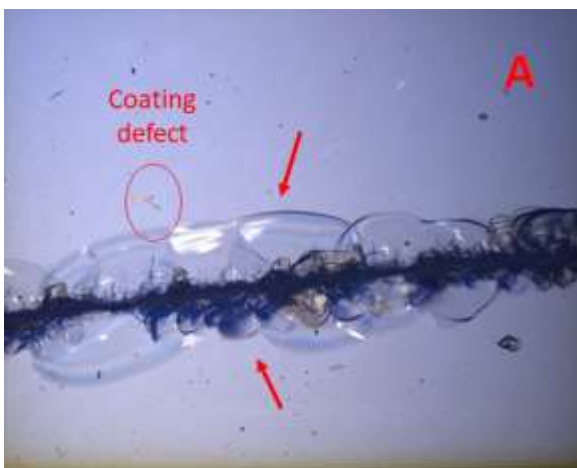
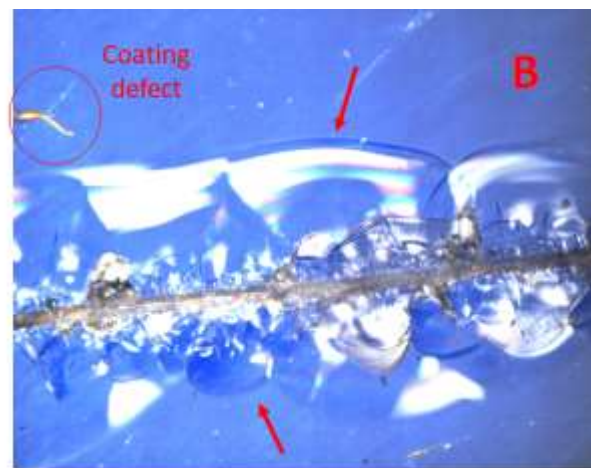
Same picture of scratch but B with higher magnification than A. on both we can see the inner cracks around the scratch.

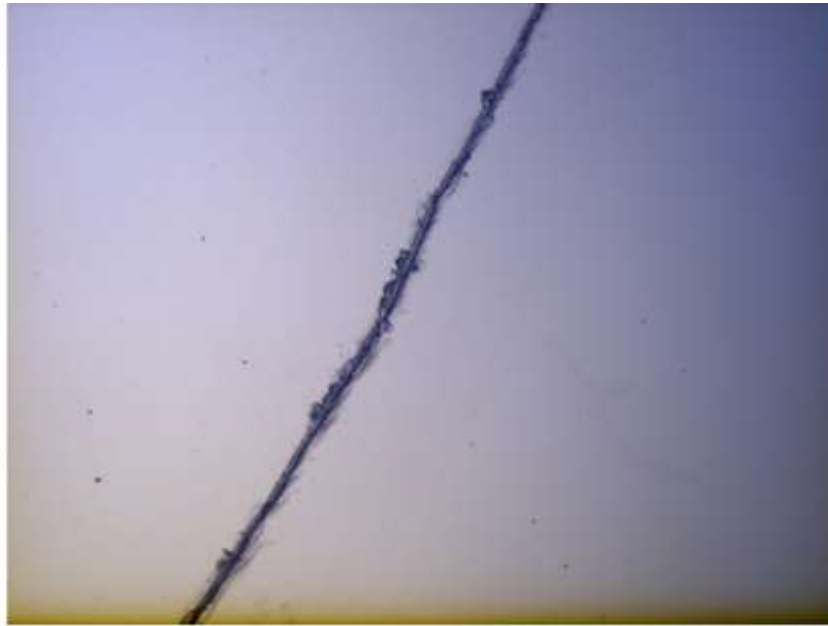
Scratch on uncoated glass of 310 μm width with inner cracks around
